## Aircraft Accident Summary Résumé d'accident d'aéronef

**TYPE:** Schweizer 2-33 Glider C-GCLG

**LOCATION:** Iroquois Falls Ontario

**DATE:** 26 Sep 1999

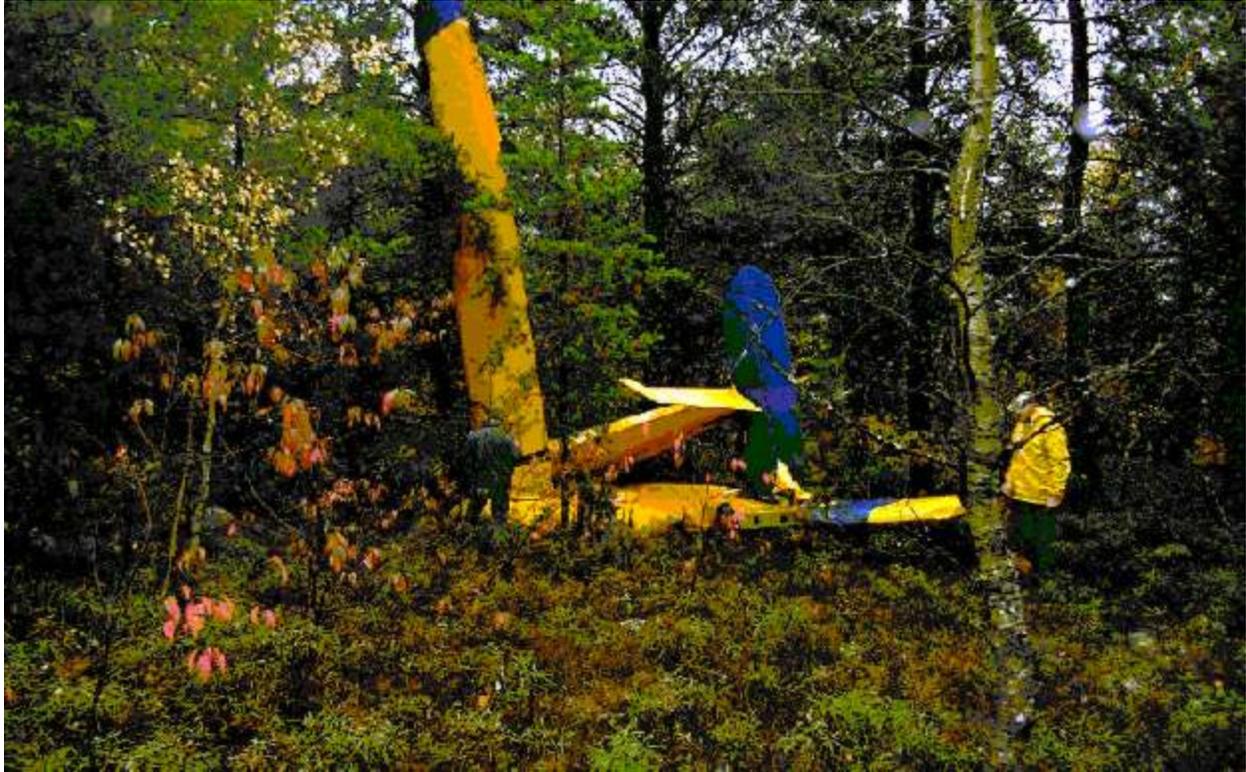
release. After a brief session of turns at altitude, the glider joined left downwind for Runway 18. The pilot did not notice that the wind at altitude had increased and proceeded to fly his circuit using the same check altitudes and ground references that had resulted in a successful approach and landing only seven minutes earlier on his previous flight. Once established on final he realised that, although he had added 20 mph to his final approach speed to compensate for the wind, he was barely making any headway towards the runway. The glider was instead descending towards trees just north of the airport boundary. The pilot elected to fly the glider between the trees and avoid stalling. The left wing struck a large pine tree approximately 25 feet above the ground and the glider came to rest on the ground with the left wing folded under the fuselage and the right wing parallel to and up against the trunk of another large pine tree. The pilot and passenger were not injured and were able to egress unassisted through the broken canopy.

The investigation determined that the pilot failed to properly assess the wind aloft and to alter his circuit accordingly, because his performance was impeded by his relative inexperience and by fatigue related to inadequate rest and nutrition before assuming his duties. The pilot had slept 4.75 hours on each of the two preceding nights due to civilian employment and had only consumed an Instant Breakfast 5 hours before the accident. Neither the Central Region Flying Orders nor the Air Cadet Gliding Program Manual, in effect at the time of the accident, included provisions to account for civilian employment in the length of the duty day. As a result of this accident, the Central Region Flying Orders now include limitations for duty day and crew rest. These limitations include both military and civilian work times in the calculation of the duty day. The National Cadet Authority will review these limitations with the aim of extending them to all regions.

The winch in use at Iroquois Falls is of a unique design. Being self-propelled, its engine is kept running constantly except during rest and meal periods. This fact defies the rule on rotating beacons as described in the A-CR-CCP-242, which is that the rotating beacon must be illuminated any time the ignition is on thereby warning personnel on the site that a glider launch is about to take place. If this winch were equipped with a rotating beacon, in accordance with regulations, its constant operation would desensitize personnel to the dangers for which it was designed for. Therefore, the direction contained in A-CR-CCP-242 with regards to the need for an amber light will be clarified for non-standard winches. Winches will be required to have a rotating beacon that will indicate that the operator is about to launch a glider.

All aspects of the site's emergency response plan were handled adequately. Unfortunately, this plan, and most other region's plans, does not include any direction as to the notification of the parents of cadets flying as passengers after an accident. As these famil sessions are being conducted with very young passengers, it is understandable that some parents might become very upset if not notified immediately of their child's involvement in an air accident. As a result, all Gliding Sites Emergency Response Plans will be reviewed by RCA Ops Os to ensure they include provisions for the immediate notification of the parents of children involved in an air accident. As well, Regional Cadet Headquarters will be assigned responsibility to follow up on the care of individuals involved in accidents.
